INTERIM REPORT ON MOISTURE UNDER PAVEMENTS

Kent A. Healy, Associate Professor
Richard P. Long, Assistant Professor
Civil Engineering Dept.
University of Connecticut

JHR-PR-69-25

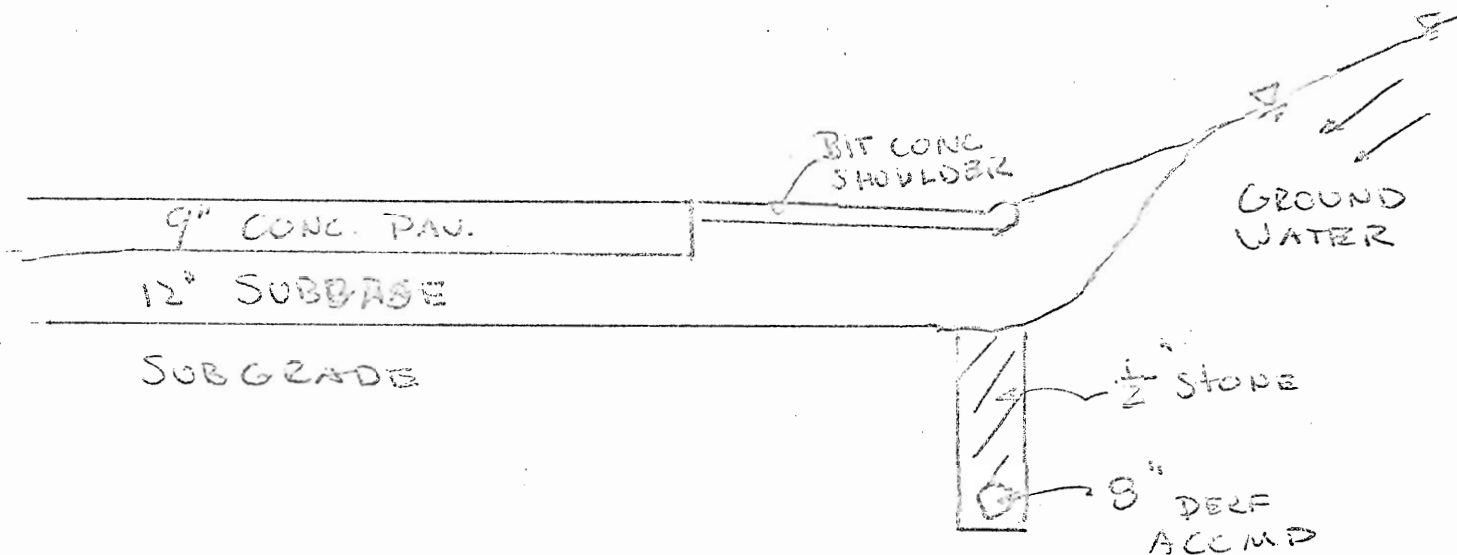
| Concrete pavement | - poor concrete, asphalt overlay |
| Subbase | - dirty gravel, nonfrost susceptible,

permeability = 10^{-4} ft/min |

| Subgrade | - clayey silt, permeability = 10^{-7} ft/min |
| Underdrain | - ineffective, $\frac{1}{2}$ " stone, clogged on periphery |

1. Concrete pavement is cracked, joints open.
2. Adjacent slope is saturated in spring. Water runs laterally under shoulder into subbase beneath pavement. Subbase is saturated in the spring.
3. Water runs longitudinally in subbase and flows out of lateral joints downhill to west.
4. There are no signs of frost heaving during cold weather.

1. Water from adjacent slope bypasses underdrain and saturates subbase.
2. Lack of support from subbase weakened by saturation resulted in cracked pavement.

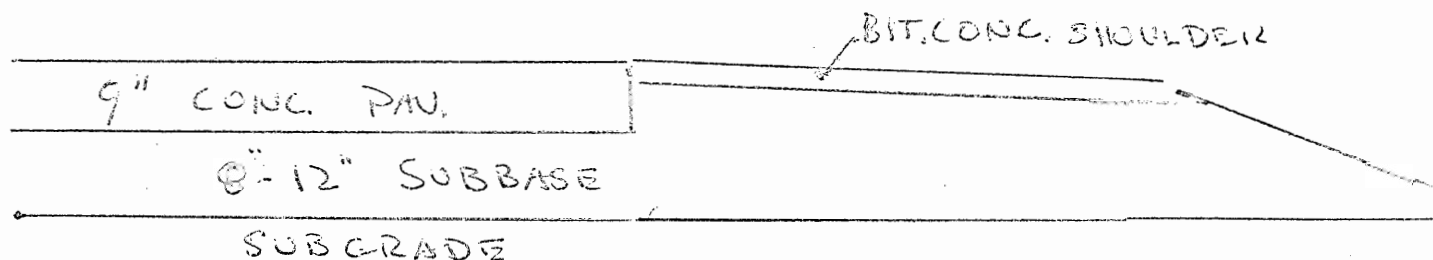
Case D. Rt. 15 Tolland (near exit 99, Rt. 195)

- Pavement - Generally good condition, but some slabs are extensively cracked.
- Subbase - Non-frost susceptible 6% < 200 sieve, $K = 2 \times 10^{-4}$ ft/in
- Subgrade - Moderately frost susceptible $K = 1 \times 10^{-5}$ ft/min, 15% < 200 sieve

1. Substantial joint shifting during winter (lateral and longitudinal)
2. Pavement breakage where subbase is less than 10" thick
3. Water table is generally low in the area. No signs of pumping; some water issuing from joints after rain.

1. Frost heave in subgrade, with subbase too thin to prevent damage to pavement, and shifting of slabs.

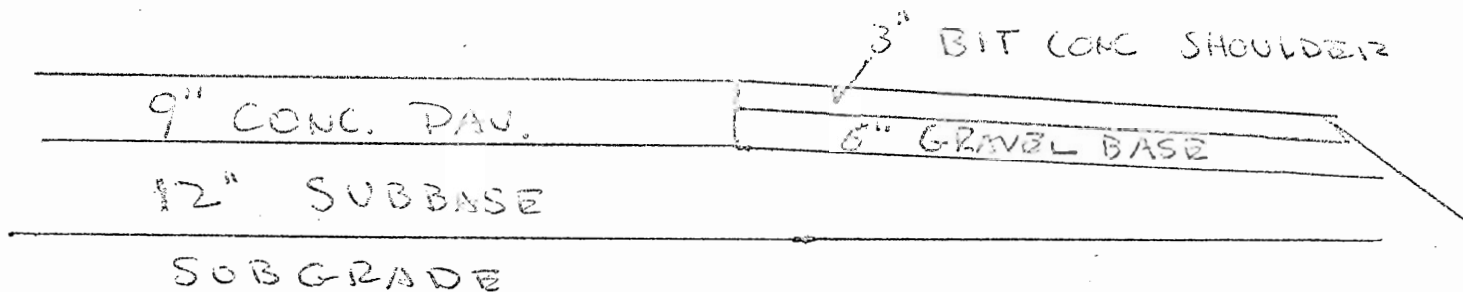
Rt. 2 Colchester

Gravel Base - frost susceptible

Subbase - non-frost susceptible

1. Shoulder heaves locally 2" - 3" above concrete pavement.
2. Water table is well down in area.

Frost susceptible soil directly under shoulder.
