INSTALLATION OF PREFABRICATED  
UNDERDRAINS ON RT. 82 EXTENSION  
Haddam, Connecticut

Report #5

Project 67-2

JHR 71-41

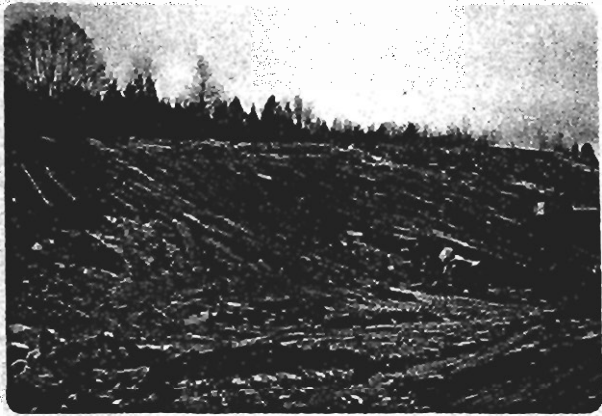
In the spring of 1971 two sections of the slope, indicated by area A and B in figure (1), sloughed due to groundwater seeping out the face. After a discussion between Profs. Healy and Long of the University of Connecticut and Messrs. Foley and Stephens from the District 2 Office of the Bureau of Highways, it was decided to install a 300 foot length of prefabricated underdrain in order to prevent further sloughing. This report describes the installation of the prefabricated underdrains.

1. Slope April 1971, Note  
Wet Areas & Manholes

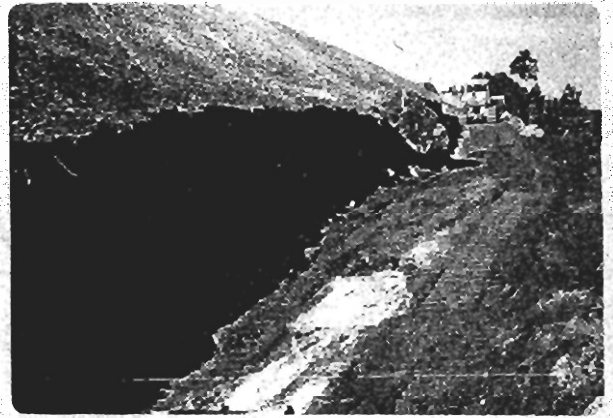
1. When the berm was cut, the flow of groundwater was concentrated in 2 spots. In one spot the sand filter of the original underdrain was exposed and the groundwater flowed along the top of this sand for 10-15 feet before it was absorbed. The sand appeared clean and a sample was taken for a permeability test. The permeability measured was  $5 \times 10^{-3}$  feet/min. which was apparently not high enough to absorb the concentrated flow of water.
2. The man hole at the end of the drain allows measurement of the flow out of the drains. When the prefabricated drain had been installed, its flow was 0.7 gpm. The flow from the longer original drain was 0.4 gpm.

2. Berm Cut by Bulldozer, Note  
Grey Sand of Original Underdrain

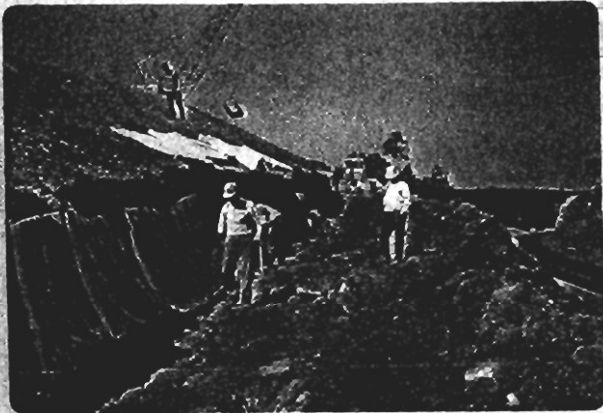
3. Prefabricated Underdrain Being Placed

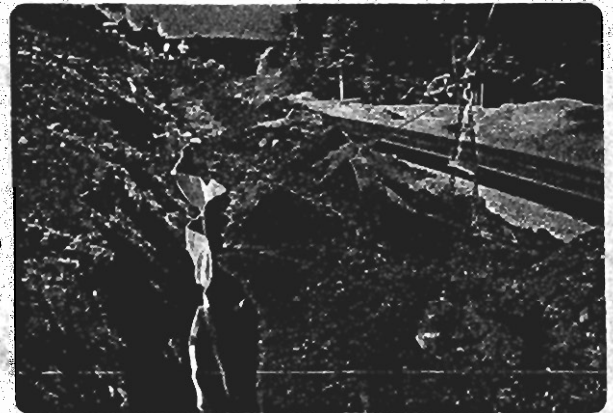
4. Dragline Backfilling Underdrain

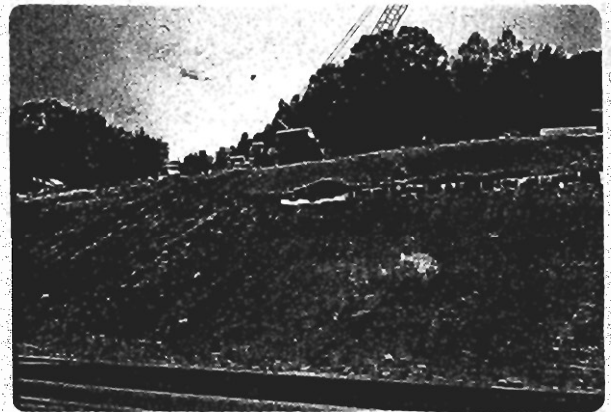
6. Partially Backfilled  
Prefabricated Underdrain
