**NINE YEAR EVALUATION
of
RECYCLED RUBBER IN ROADS
Final Report, Project 86-8**

**Prepared by: Jack E. Stephens
Prof. Emeritus, Civil Engineering
University of Connecticut**

May 1989

JHR 89-183

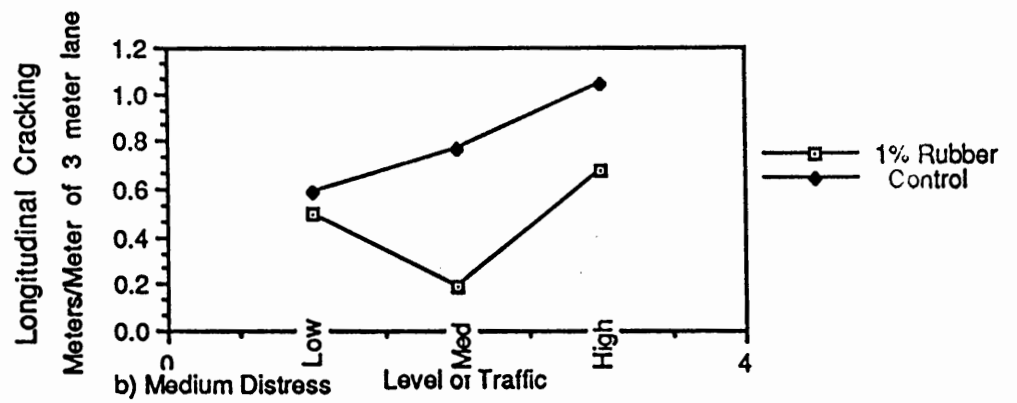
Figure 3. Longitudinal Cracking versus Traffic, 1% Rubber, 9 Years

Figure 3 depicts longitudinal cracking versus traffic. The one percent rubber sections over highly distressed pavement suffered more longitudinal cracking than the controls at all levels of traffic. Over medium distressed pavement, the controls had more cracks at all traffic levels than the overlays with one percent rubber, however the difference was small. The rubber and controls performed about equally when over lowly distressed pavements.

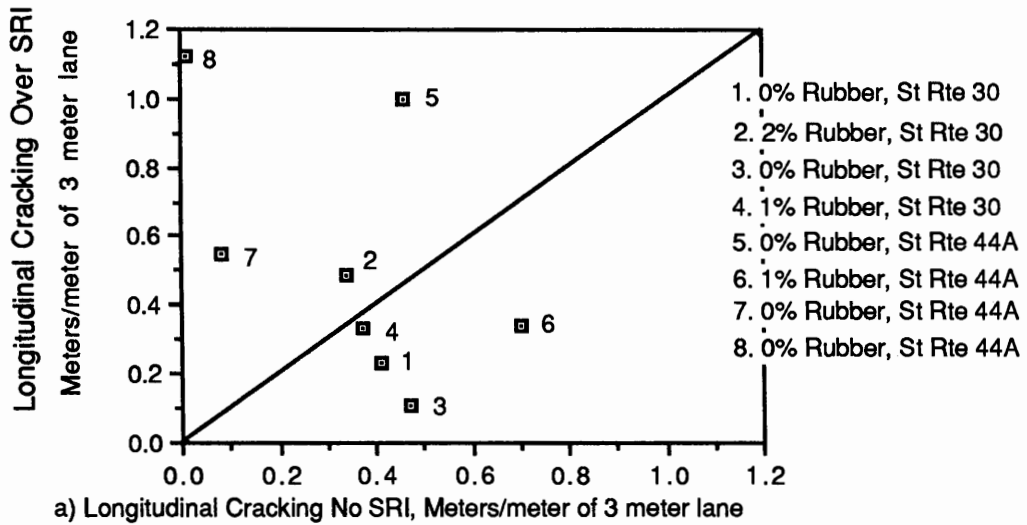
Figure 28. Comparison of Cracking With and Without Stress Relieving Interlayer

The (a) portion of figure 28 plots the longitudinal cracking of overlays with and without a SRI. The diagonal line represents equivalent performance, with and without a SRI. Points 1, 3, 5 and 7 are for 0% overlays and are respectively the controls for the 2 and 1 percent rubber overlays on St Rte 30 and the 1 and 2 percent on Rte 44A. The scatter of these points indicates the degree to which the physical condition at the sites differ. The SRI under the overlay at 3 reduced the amount of longitudinal cracking .4 meters per lane meter but at 5 and 7 increased the cracking .5 meters. The average of these four falls very near the 1:1 correlation line. 2, 4 and 6 are in the same cluster and the addition of rubber to the overlay did not reduce the amount of cracking.

In figure 28b, the cluster of 1, 3, 5 and 7 is much tighter. This could be anticipated as transverse cracking is related more directly to temperature than support conditions. The last portion of figure 28 portrays alligator cracking which is usually due to soft areas in the base, often caused by poor internal drainage. Several of the short test sections contained no alligatored areas. A single alligator area can then throw a test section into the extreme portions of the figure. If truly random, an equal number would occur above and below the correlation line (8 and 4).

An over view of all three portions of figure may be significant. There are 12 points plotted for 0 percent rubber (points 1, 3, 5, 7 in each of three plots) which fall equally above and below the correlation line, implying that the SRI did

little to benefit the pavement. Of the six plotted points for 1% rubber (4 and 6), five are below the line and indicate that SRI improved the performance of 1% overlays. Five of the six points plotted for 2% rubber (2 and 8) fall above the line. Three are substantially above indicating that the performance of 2% rubber was significantly reduced by the inclusion of a SRI.

The poor response of overlays over SRI may be explained by the construction procedure used. In order to place the overlay with a standard paver, substantial amounts of stone were spread on the interlayer. The overlay rested on this stone. Compaction of the hot overlay could force the chips down through the SRI layer to the old surface. The stone/rubber/asphalt layer would no longer function as a stress relieving layer as shear stresses could develop at both interfaces. That the effect was different for longitudinal and transverse cracking is probably explained by the rate of loading. Longitudinal cracking is related to wheel loading which would be rapid. Transverse is related to temperature which is a slow loading.
